DESIGN AND DEVELOPMENT OF COCONUT PALM (*Cocos nucifera* L.) ROOF SHINGLES

by
A.R. Floresca, F.R. Siriban and A.P. Gesmundo¹

ABSTRACT

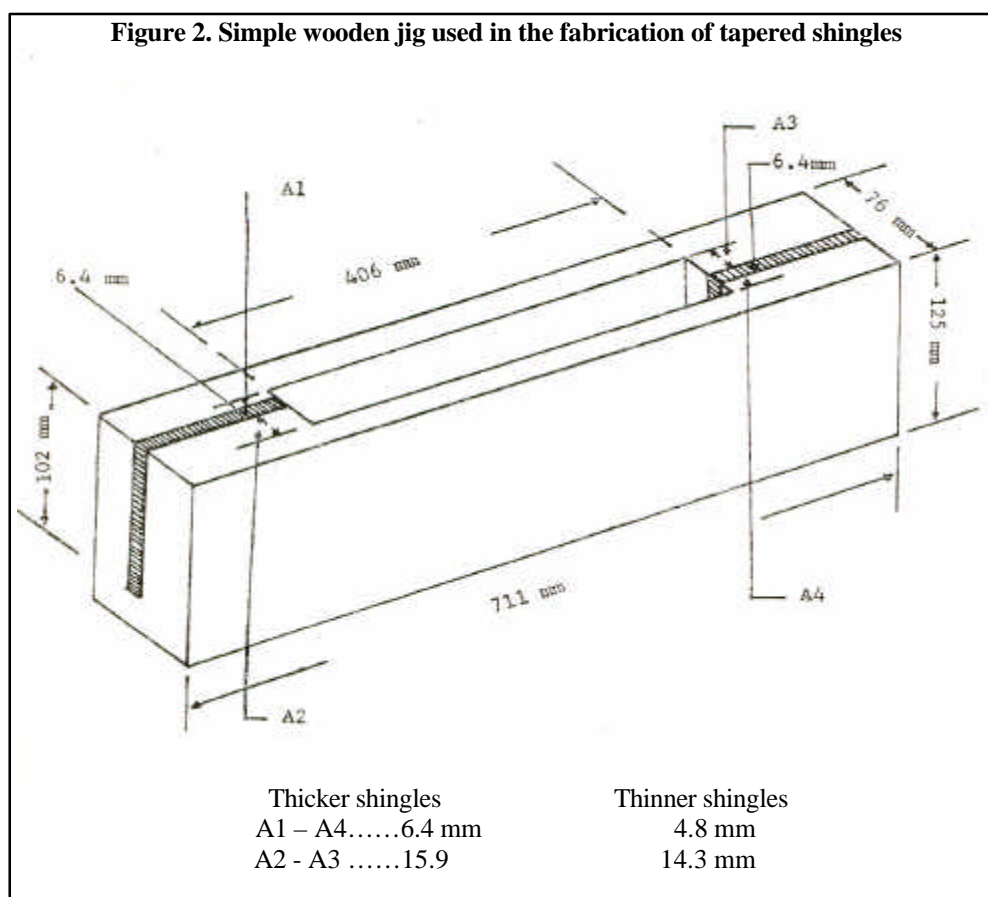
The 3,000 mm long log samples (butt portion) of coconut were converted into 32 x 110 mm flitches, then air-dried for about 3 to 4 weeks. Coconut wood flitches with medium and high density were used for roof shingles. The flitches were planed to a uniform thickness of 25/27 mm and width of 102 mm prior to cutting into 406 mm long "blank" forms (Fig. 1). The blanks were sawn into tapered shingles using a simple wooden jig (Fig. 2) to hold the blank when fed manually to the table saw. The final product are two pieces of tapered shingles which were 102 mm wide, 406 mm long, and 4.8/6.4 mm thick at the thin end and 14.3/15.9 mm at the thicker end (Fig. 3).

The fabricated shingles from coconut wood had a width of 102 mm and length of 406 mm with thickness of 14.3/15.9 mm on one end and 4.8/6.4 mm on the other (Fig. 3). The estimated fabrication cost per shingle was about US\$0.025. The average time required for the fabrication of a shingle was 3 min. and 25 sec. The total number of coconut wood shingles that could be fabricated per hour from "blank" form to tapered shingles was 250 pieces. The average retention (kg/m^3) and absorption (g/m^2), and treatment cost per shingle for the different preservatives used are presented in Tables 1 and 2, respectively. Generally, thicker shingles and medium density coconut wood shingles had higher retention and absorption than thinner shingle and high density coconut wood shingles. This means that treatment cost per shingle was also higher in thicker and medium density coconut wood shingles than the thinner and high density coconut wood shingles. In the installation or laying of coconut wood shingles, it was estimated that the cost per m was US\$1.825 (Table 3).

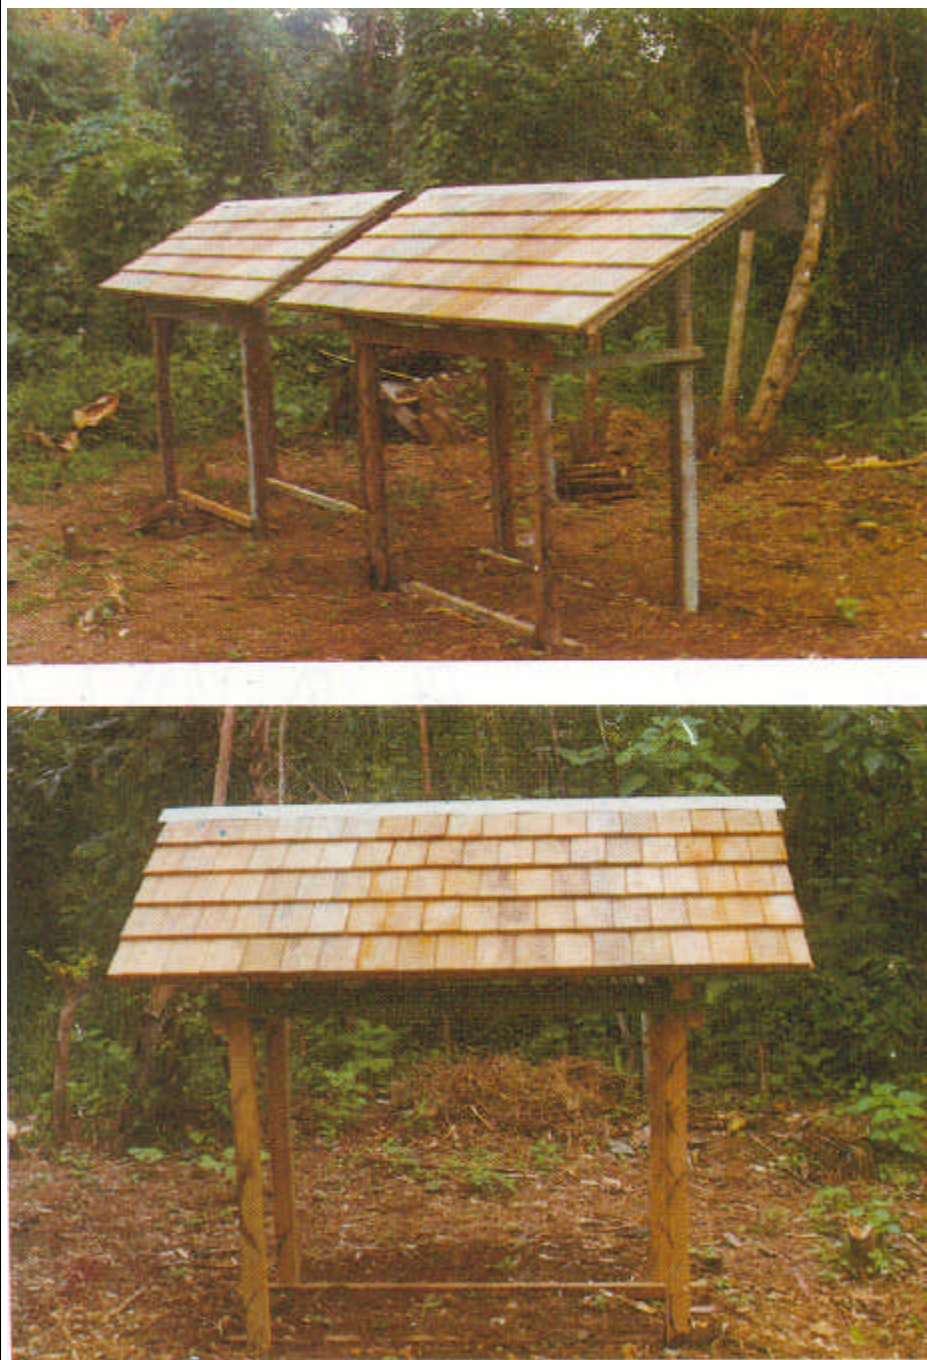
Figure 4. Coconut wood roof shingles exposed outdoors at the FPRDI “graveyard” area.

The treated and untreated roof shingles were installed side by side in roof framed structures and exposed outdoors in the FPRDI "graveyard" area with 7/12 slope (Fig. 4). The shingles were exposed on January 6, 1986.

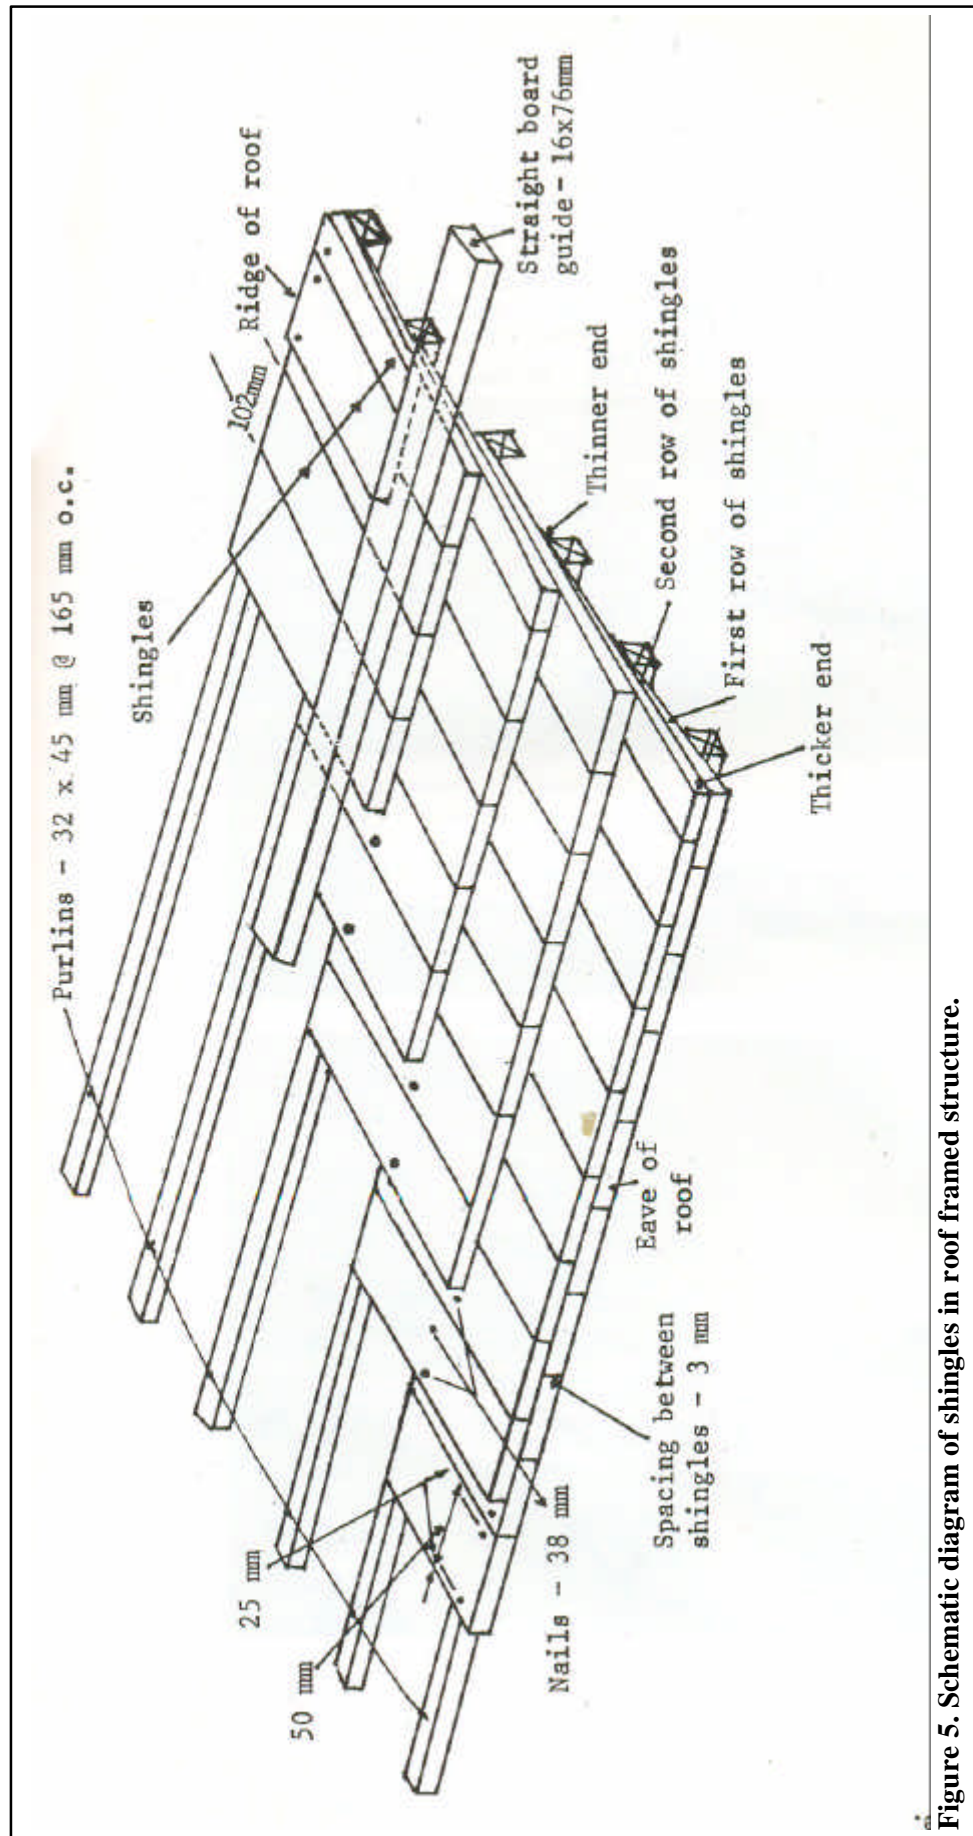
Figure 5. Schematic diagram of shingles in roof framed structure.

The shingles were installed by nailing them with a 38 mm CWN to the 32 mm x 45 mm purlins spaced 165mm o.c (Fig. 5). Installation of shingles began at the lowest portion of the roof framings. Shingles were installed by overlapping row by row from the eaves to the ridge. A straight wooden board was used to guide rows of shingles during installation (Fig. 5). Two nailing patterns were applied, i.e., 50% of the shingles with 2 nails and the other 50% with only 1 nail.

The first row of shingles were installed so that the thicker ends were oriented at the eaves and the thinner ends towards the ridge of the roof (Fig. 5). The thinner ends also coincided above the second purlin. Provision for swelling or expansion to prevent possible buckling or warping of shingles have been made by providing 3 mm spacing between the shingles when placed side by side. The shingles were nailed by driving 2 nails spaced 50 mm apart and edge distance of 25 mm thru the first purlin only. To prevent splitting, coconut shingles were prebored about 80% of the nail diameter prior to nailing. The protruding portion of shingles installed at the first row were trimmed at a distance of about 54 mm from the centre of the first purlin.

The second row of shingles was installed so that it covered the side joints of the first row of shingles (Fig. 5). The thicker ends were also oriented at the eaves and the thinner ends exactly above the third purlin. Side spacing of shingles used was 3 mm apart. The shingles were nailed in the same manner as in the first row. The nails were driven through the second purlin. At this position, the thicker ends of the shingles were exactly 53.5 mm below the centre of the first purlin.

All succeeding , odd rows of shingles were installed in line and in the same manner as in the first row of shingles, except that only one nail per shingle was used. Singles in the even rows were also installed in line and in the same manner as in the second row of shingles. Only one nail per shingle was used in the 4th row of shingle thru the purlins on which the thinner ends of proceeding row of shingles was resting.
