MARINE EXPOSURE TESTS OF COCONUT TIMBER

R. N. Palomar¹

SUMMARY

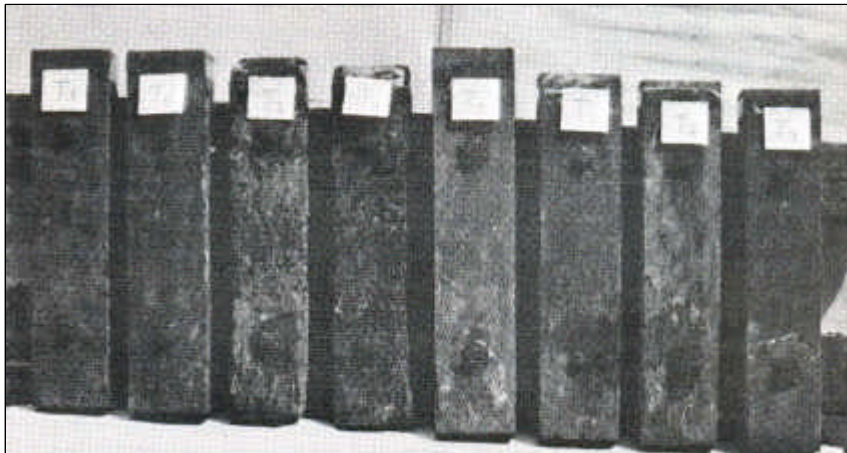
Fig. 1.
Condition/appearance of high density coconut wood panels after
Three years in sea water exposure. (L-R: T₅, T₄, T₂, T₈, T₃, T₁, T₆ and T₇).

The test panels were assessed after three years of exposure to marine borers. Results showed that the treated high density samples performed better than the medium density materials. The treated panels appeared to indicate trace to, deep and extensive infestation while the untreated wood samples failed after the exposure period (Table 3).

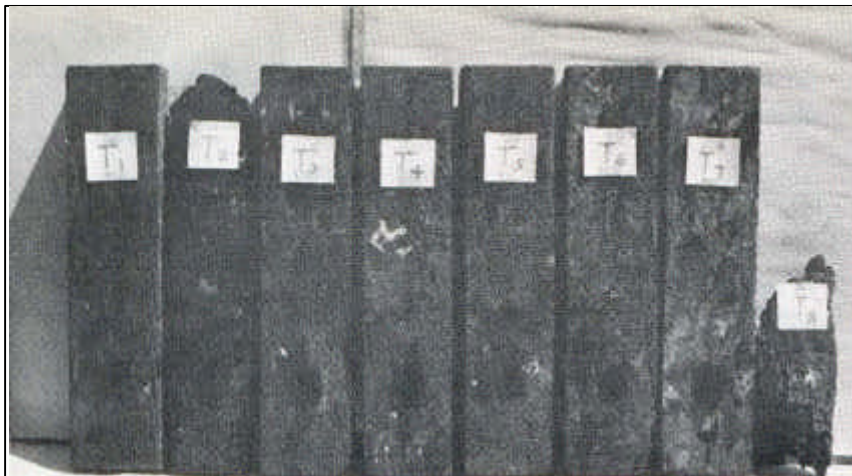
Fig. 2.
Condition/appearance of medium density coconut wood panels
After three years in sea water exposure. (L-R: T₁, T₂, T₃, T₄, T₅, T₆, T₇ and T₈)
